**Flood Control Project Maintenance
Levee Inspections**
LMA District Cover Sheet
Spring 2019 Levee Inspection Results

Reclamation District No. 1600 Mull

Spring 2019 Levee Inspection Results

Waterway			Bank	Unit Miles
Unit No. 01 Sacramento River			Right	10.46
	Spring (March - May)	Summer (June - August)	(September - November) Fall	Winter (December - February)
Unit Maintenance Rating (Fall Only)				
Date of Inspection	3/5/2019 - 3/7/2019			
DWR Inspector	Zach Jojola			
Accompanied By	Alberto De Leon DWR

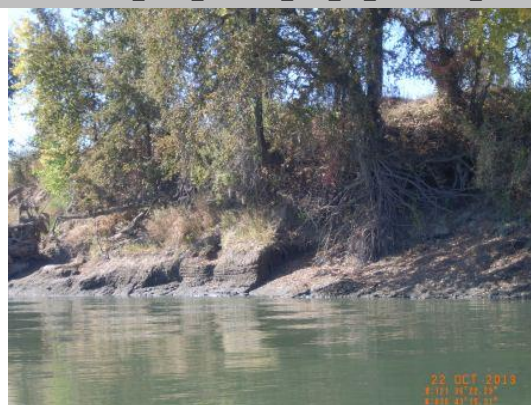
Photo 1 of 1 : SP_2019_RD1600_191_16_20190304_00004.jpg

Comment Code					
Inspector Comment					
2017 Site ID: SAC 74.4 R Status: Eroding 2017 Field Notes: Significant erosion at toe in the past year. Fresh tree popout. Site History: 1997 - Steep high bank. 2005 - Some small pockets in the low toe near the waterline. 2006 - Minor slope clearing. 2010 - Minor new erosion. 2011 - Multiple trees have fallen since last year. Some other trees look ready to fall. Significant new erosion since last year. 2012 - Minor new erosion. 2013 - Minor new erosion. 2015 - Minor new toe erosion. DWR Inspector Comment: Erosion within waterside bench and possibly sections of the waterside toe prism.

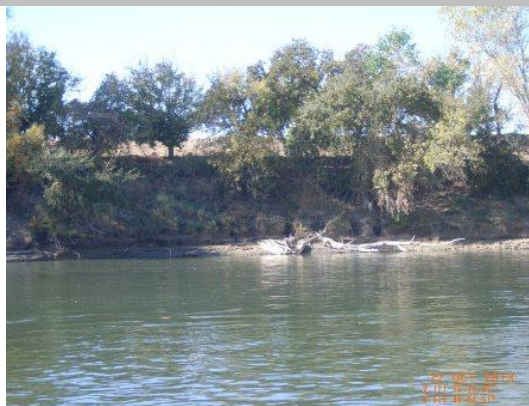
Photo 1 of 1 : SP_2019_RD1600_191_23_20190304_00013.jpg

LM Start	6.95	Rating **	M	Issue No.	23
LM End	6.98	Issue Type +	Ma	Location *	WS
Category	Supplemental			GPS Latitude/Longitude	
				Start	End
Item	2017 USACE Erosion Survey, DRAFT			38.764801 °	38.765219 °
				-121.594926 °	-121.595049 °
DWR ID	DWR_RD1600_01_f_2018_23				
Comment Code					
Inspector Comment					
2017 Site ID: SAC 77.7 R Status: Eroding 2017 Field Notes: Minor new erosion. Site History: 2006 - Eddy scour off end of rock causing erosion and scour hole near levee. Sandy silt bank with rock on upstream end. 2010 - Trees are leaning more, minor new erosion. 2011 - Many of the tree roots have scoured out and trees look ready to fall.					
DWR Inspector Comment: Continued erosion within the waterside berm.
